Leyden Wood Stove Bypass Repair Kit

SKU 250-00257

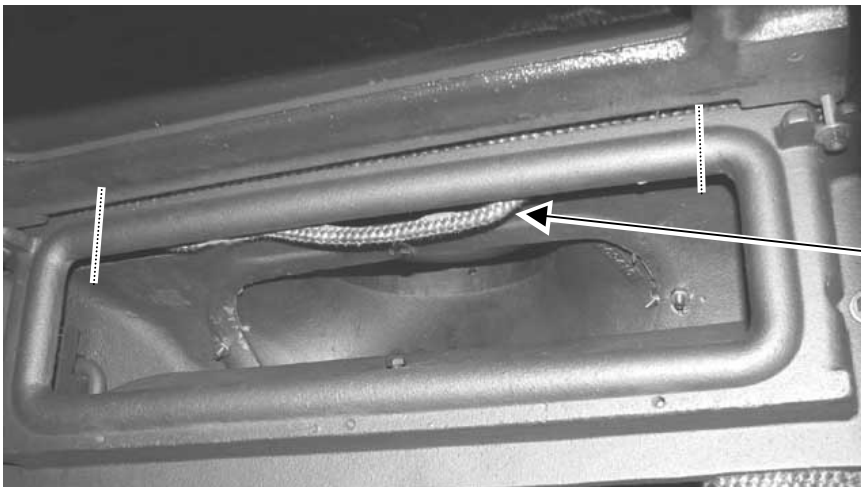
- 1 Open the bypass and inspect the bypass gasket from within the firebox. If the existing gasket is in place and un-damaged, we recommend you leave it in place and proceed to install the gasket clip (see step 2). If the gasket is drooping at the top (see the picture below) we recommend you cut the center of the gasket out and remove the center portion. If the entire gasket has detached, or is damaged, replace the entire gasket.

If the gasket is drooping in the center, simply cut the gasket along the dotted lines. Remove the gasket and replace with the included gasket.

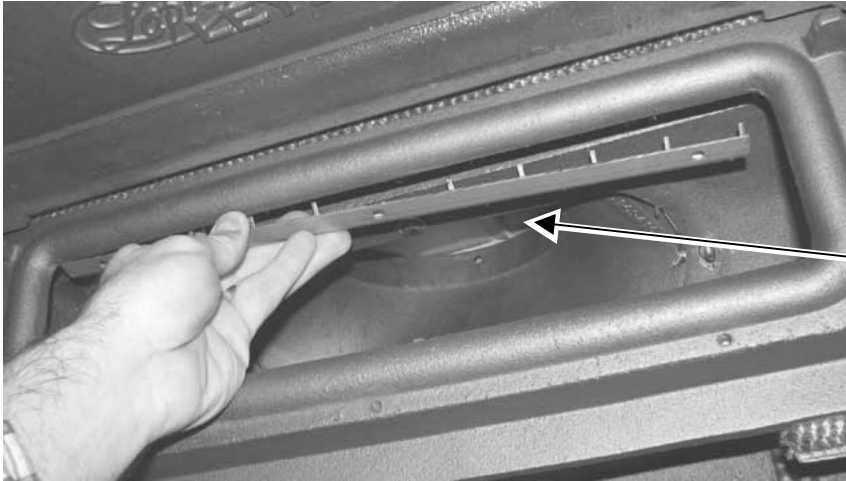
Hold the gasket clip with the pins to the rear, facing upwards. Slide the clip over the bypass gasket – the pins will depress or pierce the gasket.

- 2 Follow the steps below to mark the location of the center hole for the gasket clip.
NOTE: Take care to rotate the gasket clip into place to prevent dislodging the gasket.

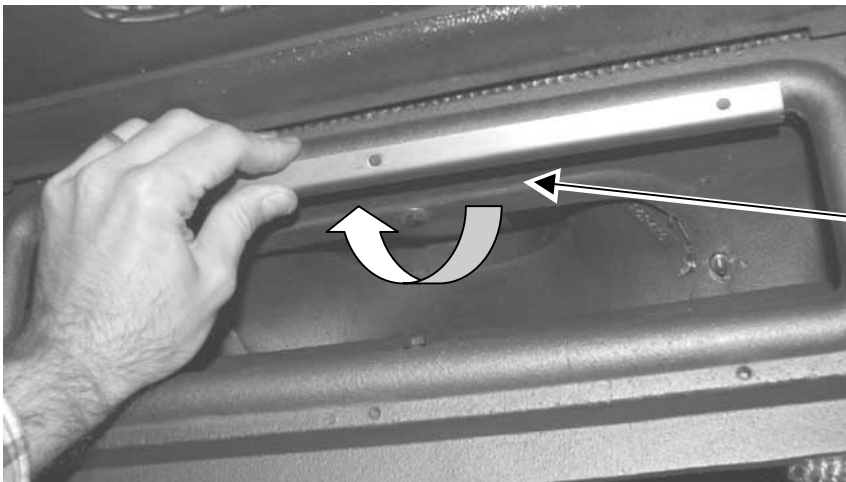
Rotate the clip forward until it is firmly against the cast iron housing.

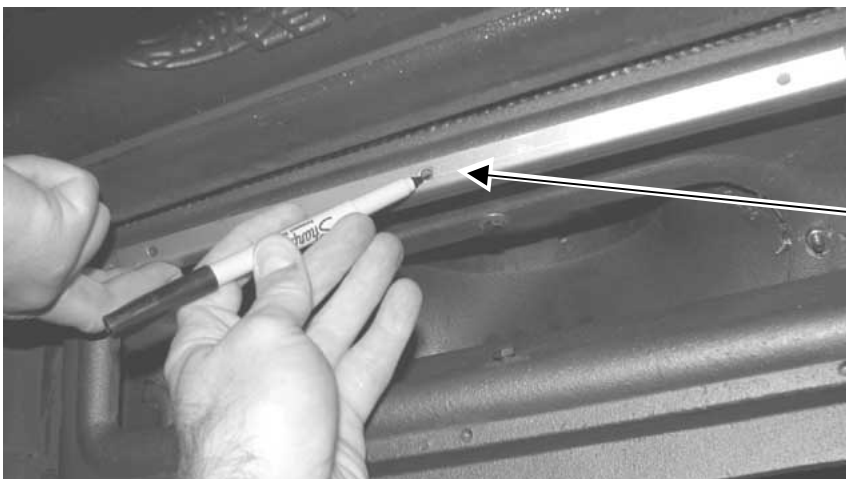
Mark the location of the center hole on the gasket clip.

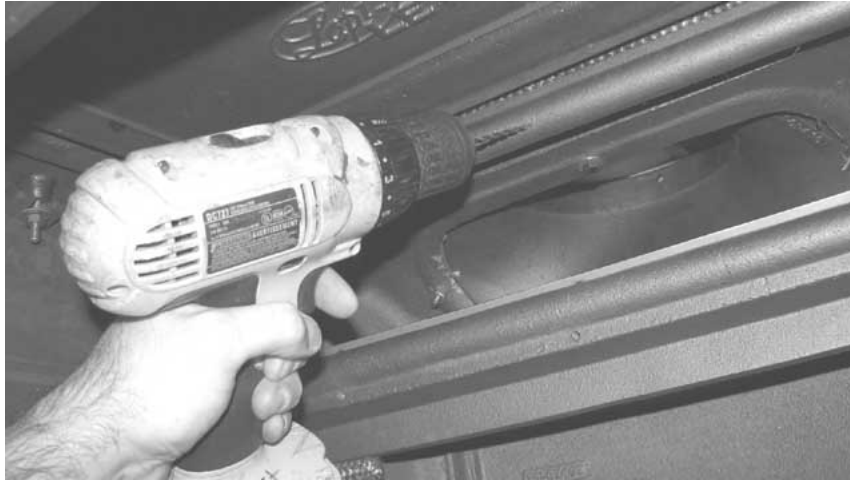
- 3 Remove the gasket clip (rotate it off the housing and gasket). Use a center punch to create a divot in the location marked in step 2. Use the included drill bit to drill an 11/64" hole in this location. **NOTE:** The drill will pass entirely through the bypass housing and may contact the bypass gasket. Make sure the gasket stays in place after drilling.

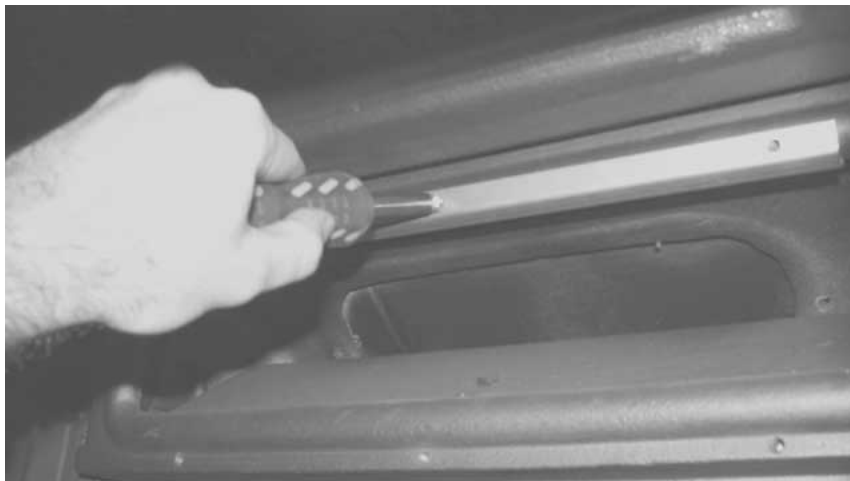
- 4 Replace the gasket clip (remember to rotate it into place) and secure it with the center screw. **NOTE:** Do not over-tighten this screw – this may cause the screw head to break off.

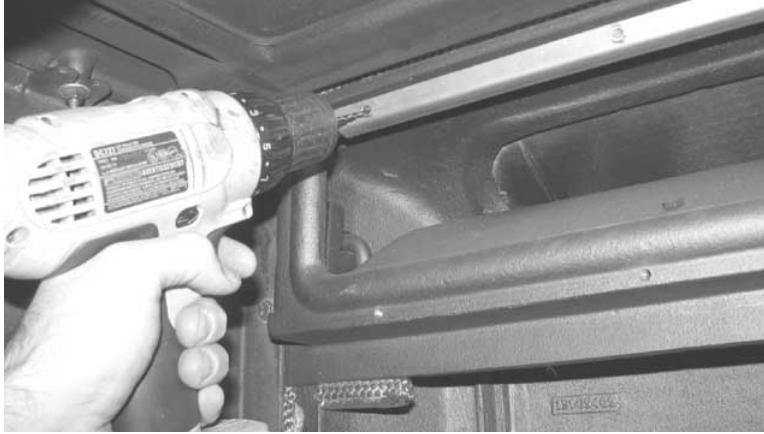
- 5 With the gasket clip in place, drill the two side holes (the clip is used as a drill fixture).

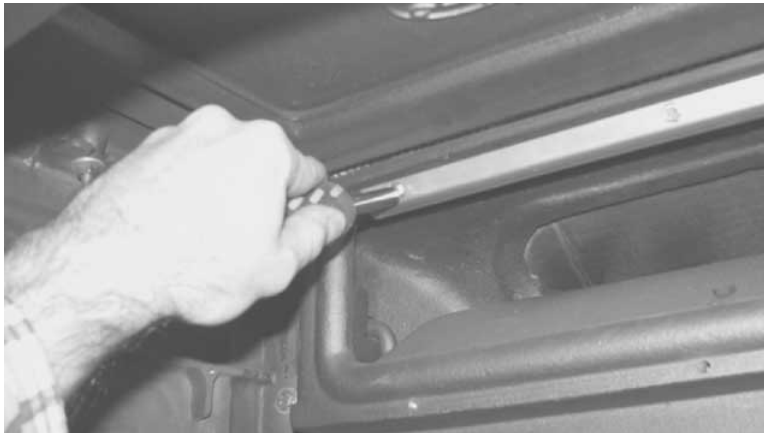
- 6 Secure the side holes with the included screws to complete the installation.

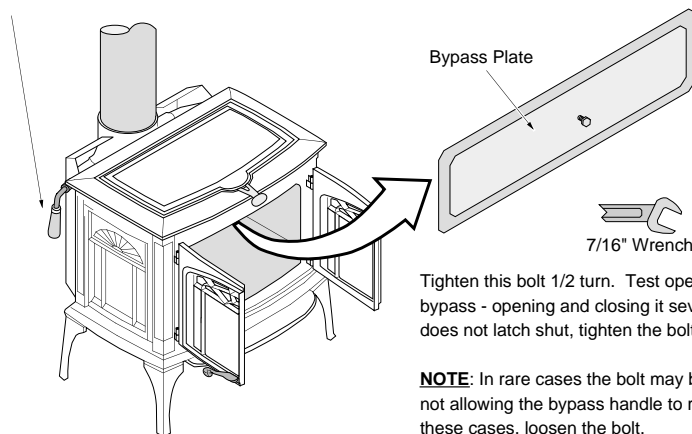
- 7 Test bypass operation. Adjust the bypass if necessary (see the illustration below).

Close the bypass -- you may need to hold it in the shut position.

Tighten this bolt 1/2 turn. Test operation of the bypass - opening and closing it several times. If it does not latch shut, tighten the bolt another 1/2 turn.

NOTE: In rare cases the bolt may be over-tightened, not allowing the bypass handle to rotate down. In these cases, loosen the bolt.
